INSPECTION STATION BULLETIN

Bulletin 10-02

Law Change Clarification & Toyota Frame Issue

2001 – 2004 MODEL YEAR TACOMA FRAME INSPECTION FOR RUST PERFORATION

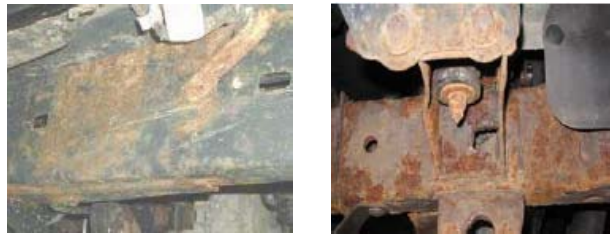
Perforation is NOT visible, and rust corrosion is present on the frame.

1. Raise the vehicle on an alignment (drive-on) rack.
2. Using a 12 to 16 oz. (340 to 450 g.) hammer, strike the side (inboard and outboard) and bottom surfaces of the frame rails using a 10-12 inch swing with light to moderate force.
3. Repeat this process at points every 2" along the frame rails ensuring that the entire area especially within the circle shown below is checked.
